Active Travel 2020-21

Mayals Road, Cycle Provision.

Stage 3. Road Safety Audit

Completion of Construction- Report Ref No. 00255.

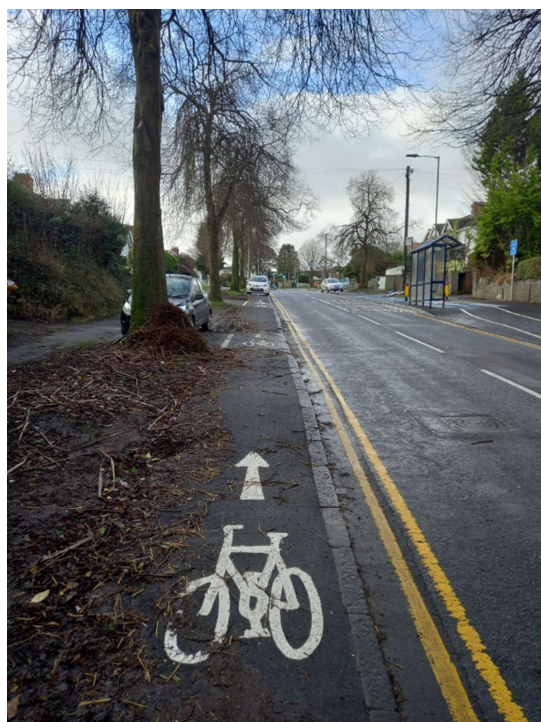
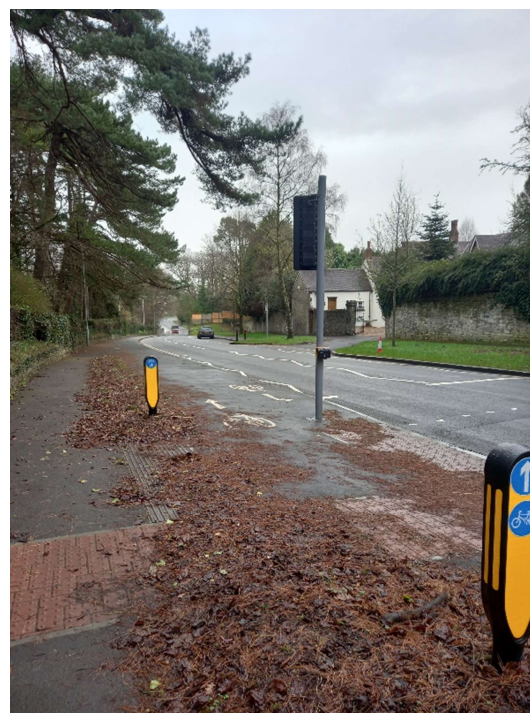
Summary: Organic Debris and mud.

Organic detritus on the surface of the new infrastructure has the potential to lead to user instability, in this case, especially to disabled users and young inexperienced cyclists using this facility. This could lead to a loss of control, skidding or unseating of the rider with the potential to enter the carriageway. Any collision resulting from this has the potential to result in serious injury.

West Bound Approaching Fairwood Rd

East Bound controlled crossing at Clyne Drive

Scheme wide debris

It is recommended that a quality review is carried out throughout the scheme to ensure it meets the needs of all users. That all affected areas of the scheme be cleared of any Fallen Organic Debris (F.O.D) and unwanted materials. An environmental assessment and arboriculture review should be carried out with a view to reducing ongoing issues. Future provision should be made for an annual clearance and sweeping of Non-Motorised Users (NMU) routes along Mayals Rd.

Designers Response – Swansea Council Highways Department operate a programmed and a Reactive Highway Maintenance Regime. Mayals Road is a primary distributor that benefits from the regularly programmed mechanical sweeping of its highways infrastructure. Swansea Council's Highways Maintenance Department has a team of Highway Inspectors who identify issues such as this.

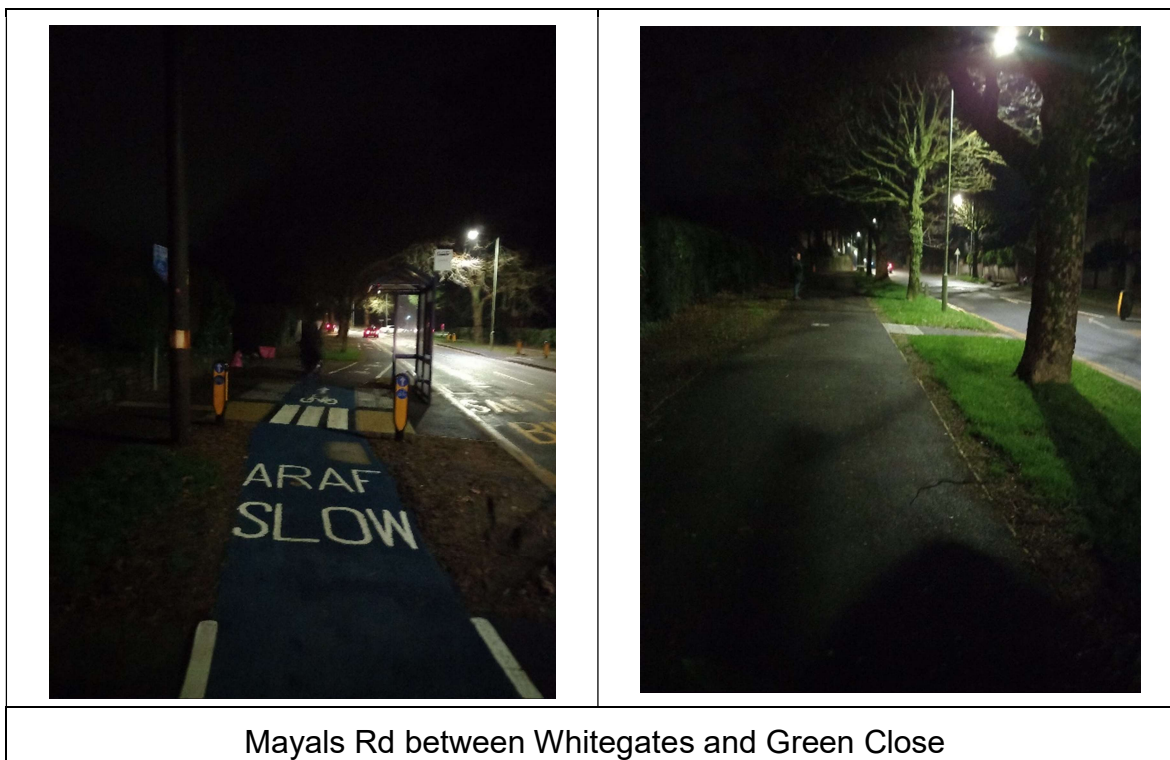
Summary: Poor light levels, unlit areas of darkness, loss of control

Existing lighting remains largely unaltered and therefore provision favours the carriageway and new cycle provision adjacent to the road. NMU's on existing footways using Mayals Rd during dark hours face poorly lit or unlit areas and loss on inter-visibility between vulnerable users. This also results in issues of personal safety whilst walking and using the bus stops. This is particularly noticeable at possible conflict locations where pedestrians and cyclists come together, such as bus stops and uncontrolled crossings. Cyclists unaware of pedestrians because of poor lighting levels, could brake late and lose control if required to take evasive action. This type of situation could possibly lead to pedestrian/cyclist conflict due to reduced perceptibility with the potential of consequential injury. Night-time observations also revealed concerns over the retro-reflectivity of bollards provided throughout the scheme.

- Light levels on poorly lit areas of the scheme be improved to benefit all users.
- Lighting within the bus stops be provided.
- Lighting levels at NMU convergence also be reviewed to increase conspicuity of layout and improved reflectivity.
- Bollard retro-reflectivity performance is poor and should be reviewed throughout the scheme.

Designers Response – Discussions with Swansea Council's Public Lighting Section during the design phase confirmed the existing public lighting system along Mayals Road conforms to the standards required in BS:EN13201. However, it is noted that the existing tree canopy may reduce the efficacy. The design team will co-ordinate with the Tree Services Team to ensure tree branches are pruned and crown lifted so they do not interfere with the street illumination levels.

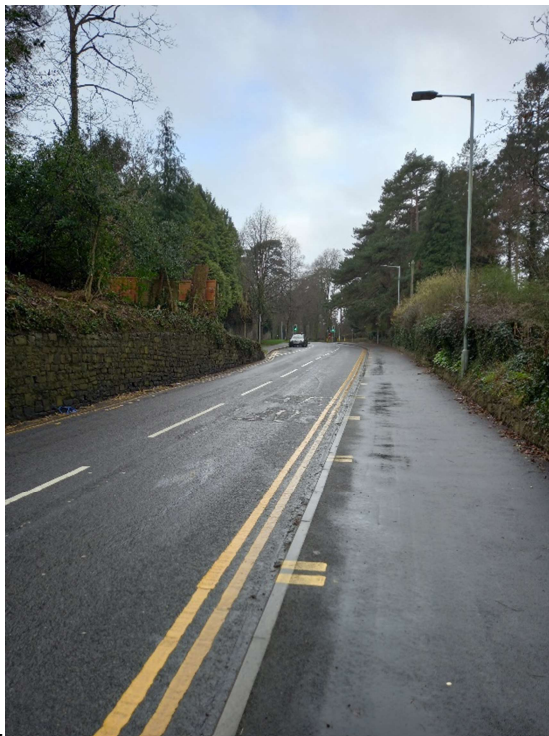
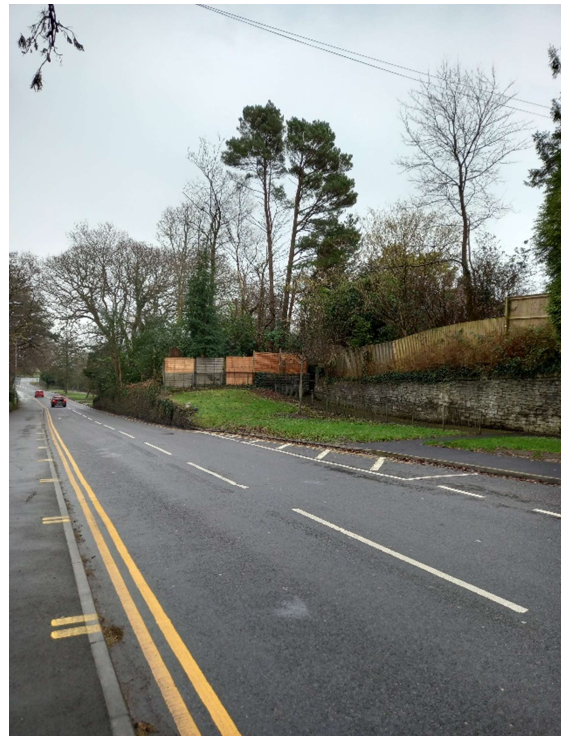
Summary: Unseen pedestrians suddenly emerging into the carriageway.

Vehicles outbound (West) uphill towards Clyne Drive, at times, are unexpectedly confronted with pedestrians emerging from behind the retaining wall and suddenly crossing Mayals Rd well before the controlled crossing. This was observed at night-time too. Some pedestrians using the existing footpath from Fernhill Close are following the existing footway and desire line but not using the controlled crossing at chainage 300. They are instead carrying on, before stepping into the carriageway at the taper at the beginning of the parking bay. Crossing at this point of Mayals Rd to go toward Mumbles Road. This area is both unlit and obscured by the existing retaining wall. This could result in a collision between vehicle and pedestrian with the potential for serious injury to occur.

West Bound

East bound

Between Mumbles Bay Court and Clyne Drive, scheme chainage 230.

It is recommended that, the kerb line and parking taper be amended and locally re-aligned to provide a more suitable and visible uncontrolled crossing point, following this desire line. Also that the area be illuminated to address issues of approach visibility at this location.

Designers Response – *The footway link and desire line from Fernhill Close whilst not ideal, is a legacy of the original highway layout. There is a signal controlled pedestrian crossing in close proximity to Fernhill Close to accommodate the pedestrian demand, the footway further east is purely to provide a pedestrian route for motorists parked at the layby. Accident records reveal that there is not an issue of pedestrian / motorist conflict at this location and the scheme has done nothing to further exacerbate this issue.*

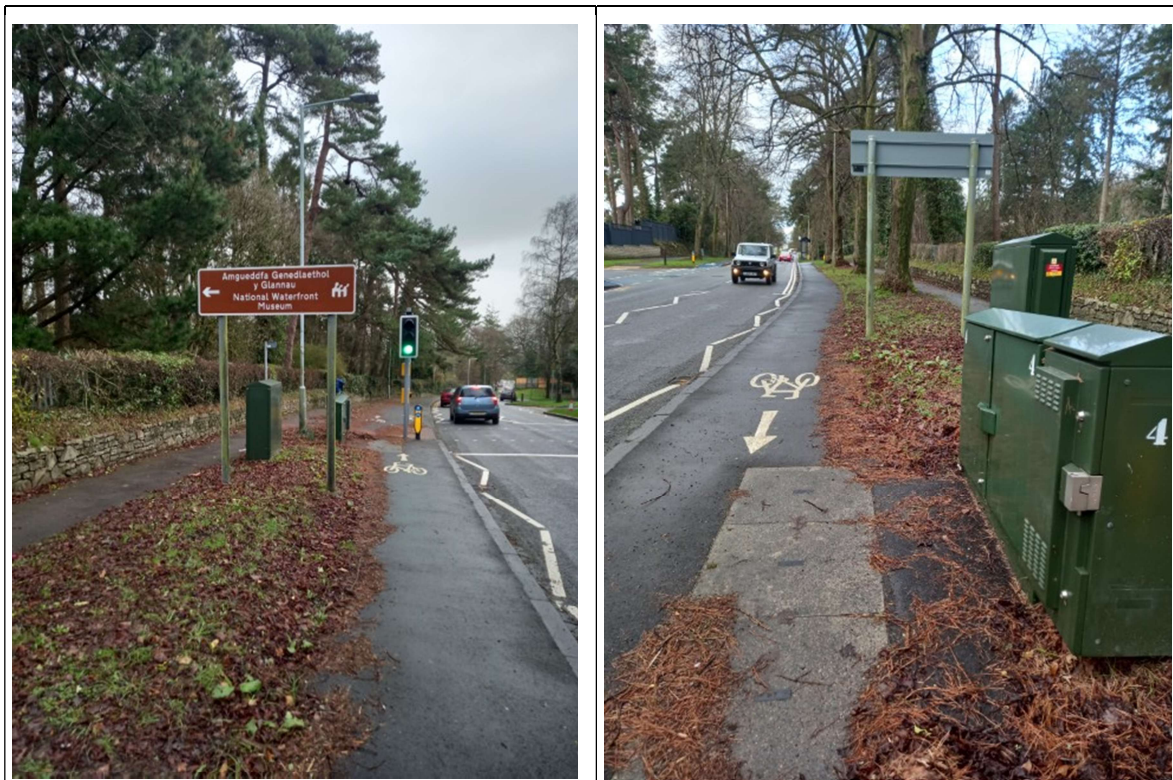
Summary: Cyclist unexpectedly forced to use carriageway, potential collision with vehicles on Mayals Road.

The existing Communications cabinet and associated access chambers position in relation to the cycle track means that, during maintenance, open doors and lifted chamber lids and barrier would compromise the use by cyclists. Potentially forcing cyclist into the carriageway to negotiate temporary obstacle. This could result in collision with vehicles going ahead inbound East on Mayals Rd, with the potential for serious injury.

Controlled crossing East of Clyne Drive, chainage 320.

It is recommended that the non-passive existing, but redundant brown on white tourist sign, a hazard in itself, adjacent to the cabinets is removed and a temporary dismount cyclist bypass route is provided to negate the temporary maintenance issue.

Designers Response – *Discussions with the telecommunications company during the design stage confirmed this communications cabinet is maintained on average 3 to 4 times a year. Any maintenance works undertaken requires the telecommunications company to temporarily close the cycle path with barriers and advance “Cyclist Dismount” signing at an appropriate location upstream. This will enable the cyclist to safely negotiate the temporary closure on foot before re-mounting and continuing their onward journey.*

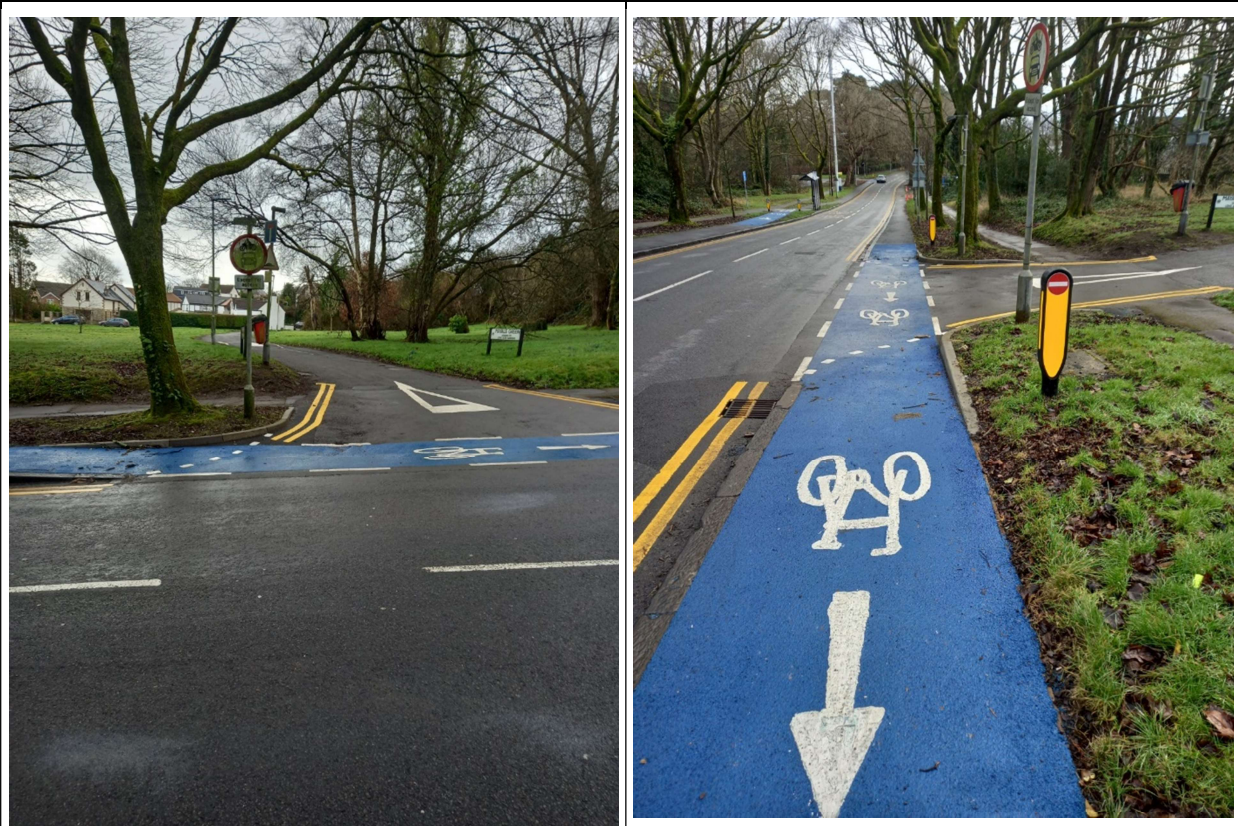
Summary: *Poor surface condition and gradient at tie in with main road.*

The Cycle provision at this junction has an uneven and pitted finish and a slick coloured surface, which could pond in winter. This could lead to loss of control or failure to stop.

Mayals Garden and Southern Down Avenue

It is recommended that the surfacing at this junction be re-graded and the coloured surface re-applied.

Designers Response – *The section of the cycle track highlighted is on an uphill section where users of the facility are likely to be travelling at low speeds. The gradient is approximately 1 in 11 (9%) at this location, therefore, surface water is unlikely to pond during any inclement weather in winter months.*

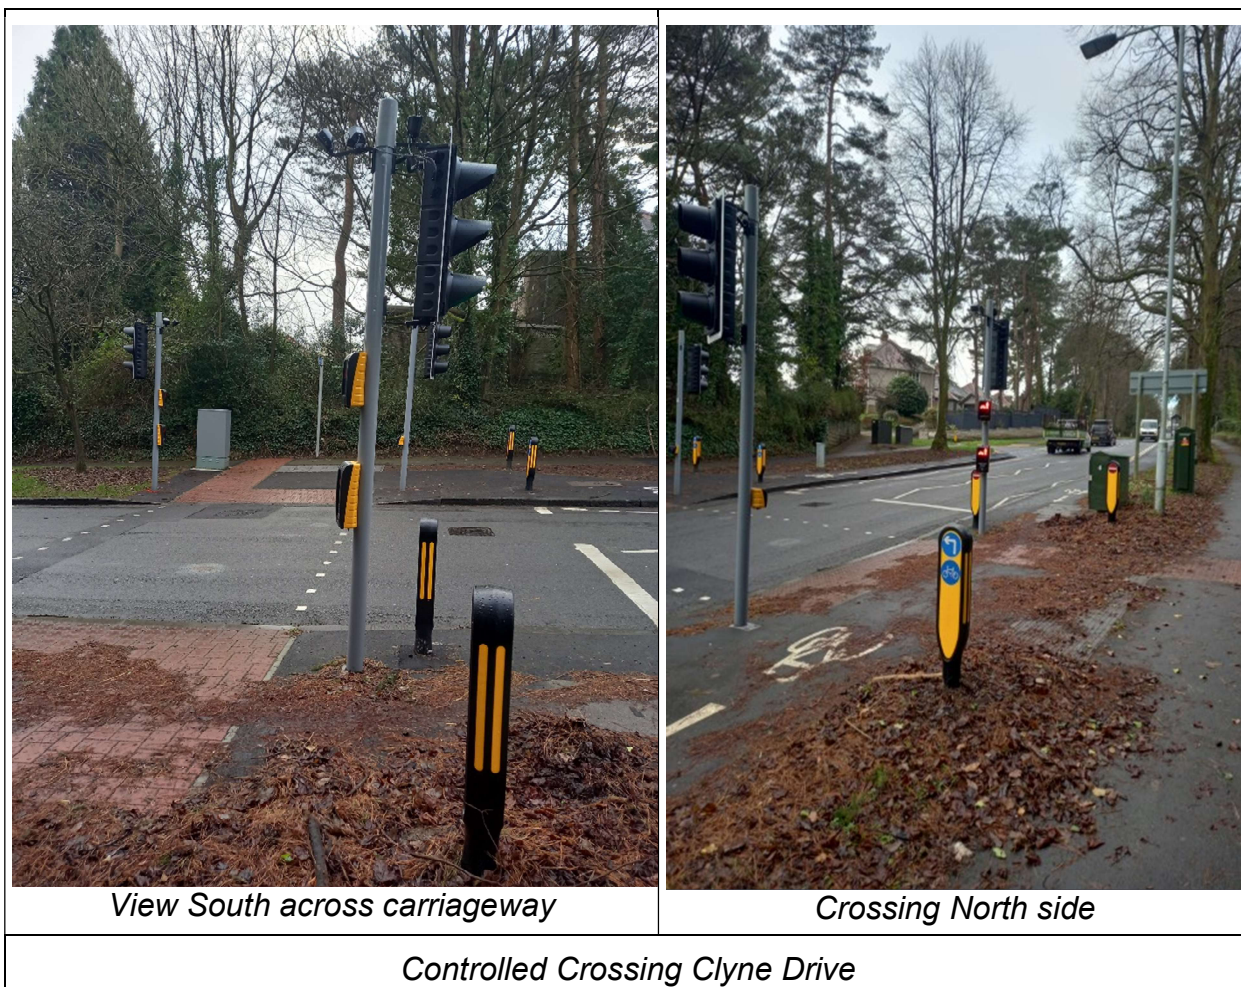
Summary: Layout and tactile provision, potential pedestrian conflict and vision-impaired hazard, exacerbated if speeding cyclists are involved.

The layout provided brings all NMU and vulnerable users together in order to use the crossing; with inbound cyclists, potentially travelling at speed. The use of tactile paving, whilst standard, is potentially disadvantageous to the vision impaired. Priority is unclear, possibly forcing cyclists unexpectedly into the carriageway to avoid contact with others at the crossing. This could result in side or rear collision with vehicles going ahead leaving the potential for consequential serious injury to occur. Vision impaired pedestrians using the tactile paving to guide them to the crossing push button may be unaware of crossing the cycle route and may even stand on it while waiting to cross. This creates potential for pedestrian and cyclist contact, especially at night, with potential for injurious collisions between pedestrians and cyclists.

It is recommended that designers revisit latest guidance. Including DFT Guidance on the Use of Tactile Paving Surfaces December 2021. With a view to simplifying and giving clarity to the provision, layout and priority around the crossing, especially for vision impaired users.

Designers Response – *Whilst the tactile crossing arrangement used is in accordance with the standard layout at this type of crossing, the design team accept that cyclist could potentially approach the crossing at speed. The design team will consider the use of additional cycle warning markings and tactile paving to ensure clarity of priority and report any findings in the Road Safety Audit Stage 4.*

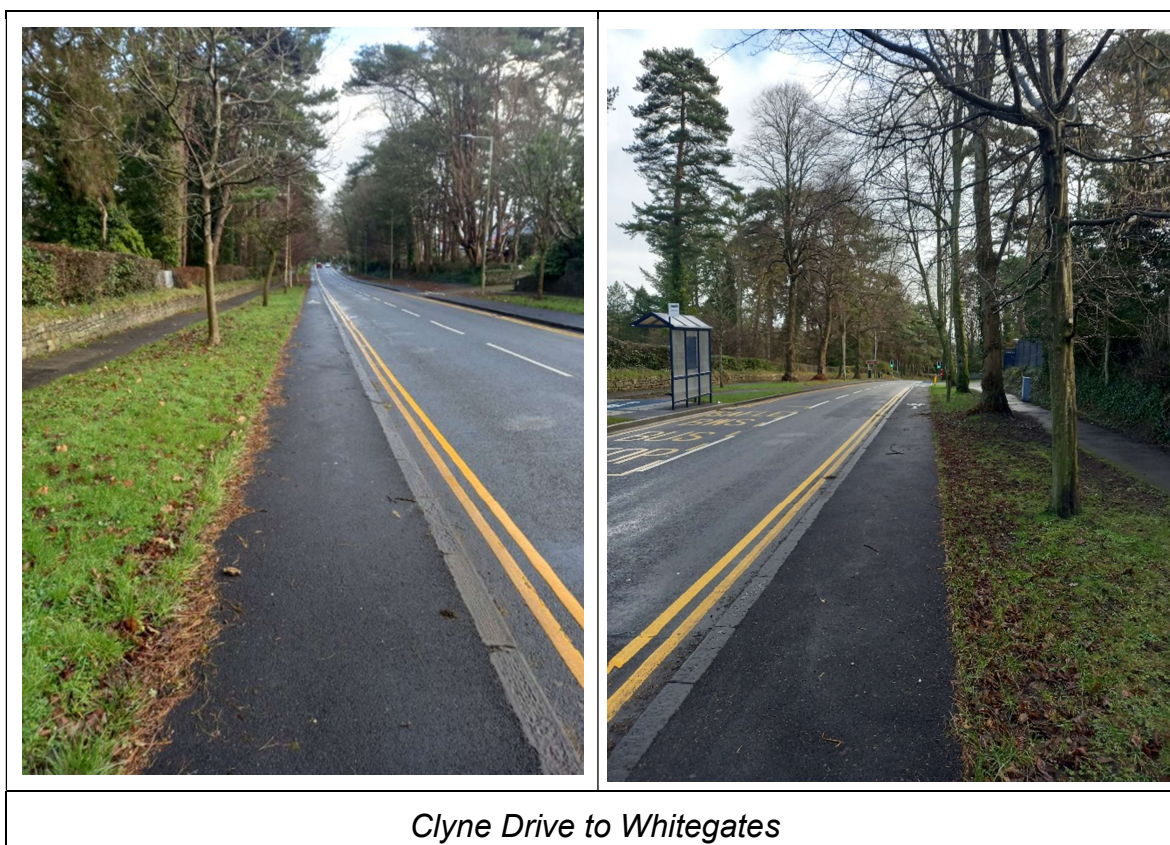
Summary: Cycle track too narrow to pass another cyclist safely.

The existing width of the cycle track will only comfortably accommodate a single cyclist going ahead. Quicker riders, obstructed by a slower cyclist ahead, especially on steeper sections, have no way of readily passing safely. Whilst it is worth commenting that with the ever-increasing use of electric assist cycles this may become less of an issue,

observations during the site visit saw cyclists dropping onto the carriageway to pass a slower rider. This manoeuvre could lead to the situation of the faster cyclist unexpectedly deviating into the path of a faster traveling vehicle on Mayals Road. This has the potential to result in a cyclist/vehicle conflict with consequential serious injury. Passing another cyclist is achieved more readily where multiple accesses exist. This additional space allows slower cyclists to move briefly to the left to facilitate the faster cyclist passing. However, there are sections, where long lengths of the cycle route are do not have this option.

Additionally, a night-time observation, saw a cyclist, without lights, using the route in the opposing direction which, if repeated, would exacerbate this issue.

It is recommended that passing places are provided on this and all other sections of Mayals Rd, where cyclist cannot utilise space provided by an access in order to pull in and be passed.

Designers Response – *Whilst the hybrid cycle facility has been designed to encourage the uptake of cycling by providing a safer cycle facility segregated from vehicular traffic and pedestrians. It is accepted that faster, more confident, experienced cyclists may opt to not use the facility and continue riding on carriageway where it is easier to pass slower users on the cycle path, especially in the downhill direction.*

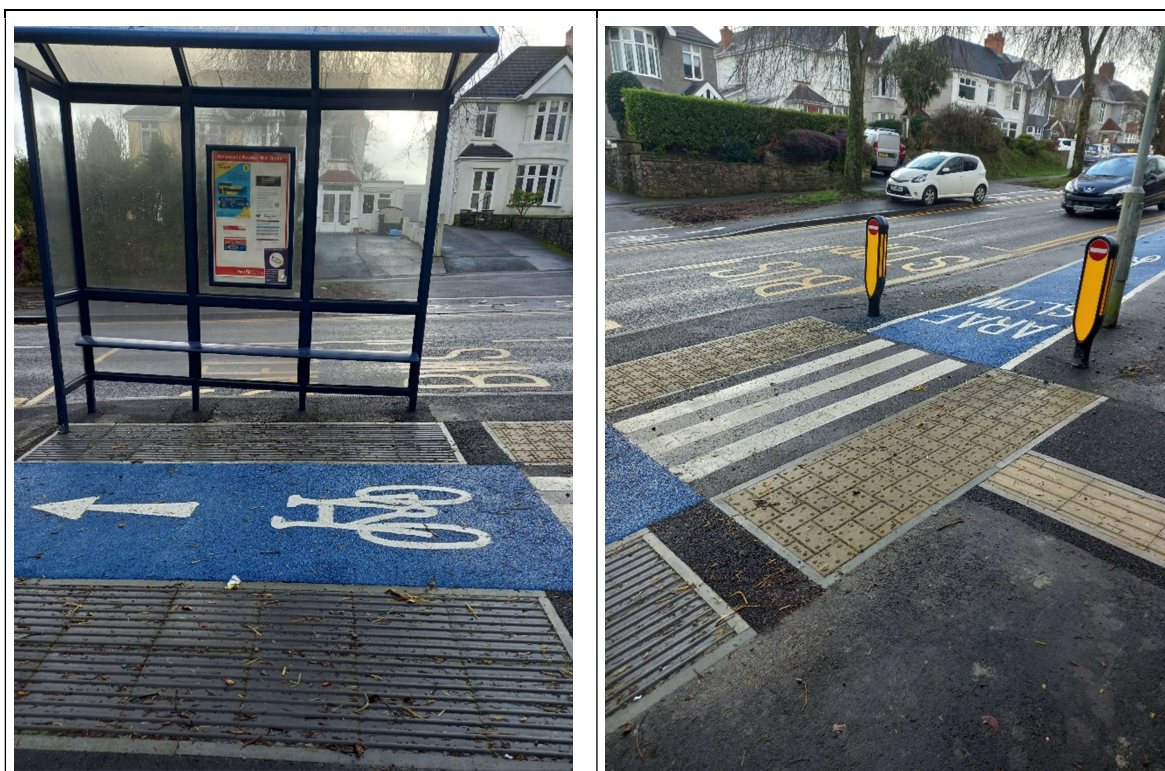
Two adjacent sets of tactile paving, either side the cycle track convey different messages. With one set appearing to indicate a hazard, crossing the cycle track, directly toward the bus shelter seating. The other set, to the right of the shelter, across the same cycle track, indicating an uncontrolled crossing with “Zebra” markings on the cycle track.

Similarly, vision impaired users, once successfully seated in the shelter are not furnished with any disability friendly information or signing to allow them to readily understand their surroundings and the immediate proximity of a passing cyclist. This has the potential to create conflict between cyclist and pedestrian with may lead to consequential injury occurring to either of both parties. Informatory signing on the footway opposite is all but useless to the vision impaired.

Night-time observation revealed that these issues are exacerbated as the area is not directly lit and presents itself as uninviting to users, possibly leading to concern over personal safety.

Scheme wide bus stop provision.

It is recommended that designers producing a simpler, logical and consistent layout, in keeping with latest guidance. User friendly to all, especially vision and mobility impaired highlighting the immediate hazards and providing additional beneficial information signing. It is also recommended that night-time illumination is provided within the shelter and immediate area to improve personal safety and awareness of surroundings to benefit both cyclists and pedestrians. These changes will also improve driver awareness of the bus stop.

Designers Response – *The original design detail of the cycle by-pass at bus stops was based on the suggested detail DE029 in the 2013 Active Travel (Wales) Design Guidance, further refined in accordance with the standard detail DE502 as noted in the 2020 Active Travel (Wales) Design Guidance. This design detail on Mayals Road included the 1 in 10 horizontal deflection on approach to the bus stop area, the mini zebra markings, cycle markings and blister tactile paving. The design team added further safety features such as additional hazard paving in the paved areas warning sight impaired individuals they were approaching a potential hazard (the cycle bypass), “SLOW/ARAF” markings on cycle approach to the bus stop area and blue coloured surface to further inform cyclists they are approaching an area where increased caution is advised. The blue coloured surface also offers a contrasting colour to sight impaired individuals indicating a change of surface/use.*

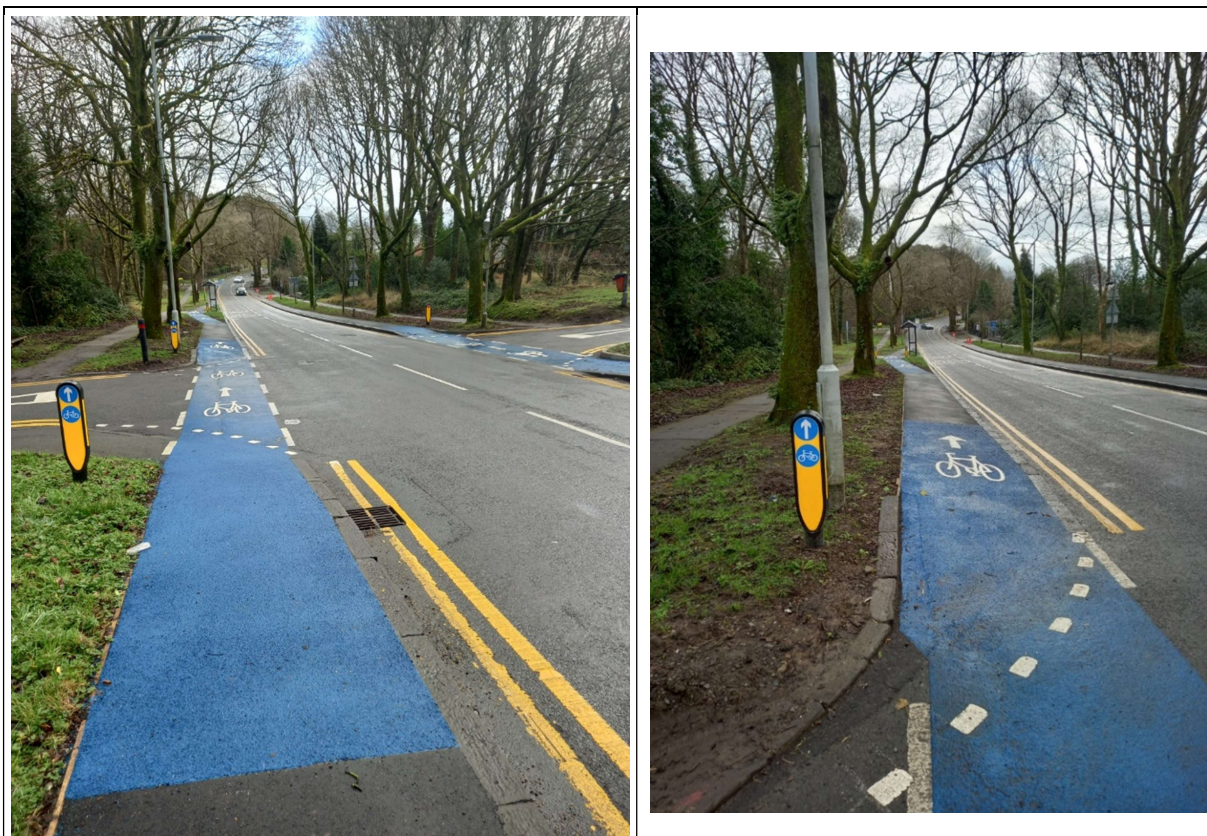
Summary: Severe camber on cycle track, leading to loss of control

Cyclists eastbound downhill, having crossed the junction with Southdown Avenue at grade, rise up to re-join the cycle track, but have to negotiate a section passing a large tree where the camber towards the carriageway is considered excessive. Younger or inexperienced riders slowing or losing momentum on this section, will naturally veer towards the road. This could lead to cyclists braking, becoming unseated and falling, or suddenly dropping unexpectedly onto carriageway in front of a passing vehicle with the potential for consequential serious injury.

Southdown Avenue junction with Mayals Road - Westbound

It is recommended that this section of the cycle track be re-graded to eliminate adverse camber and provide a safer and more user friendly surface for users.

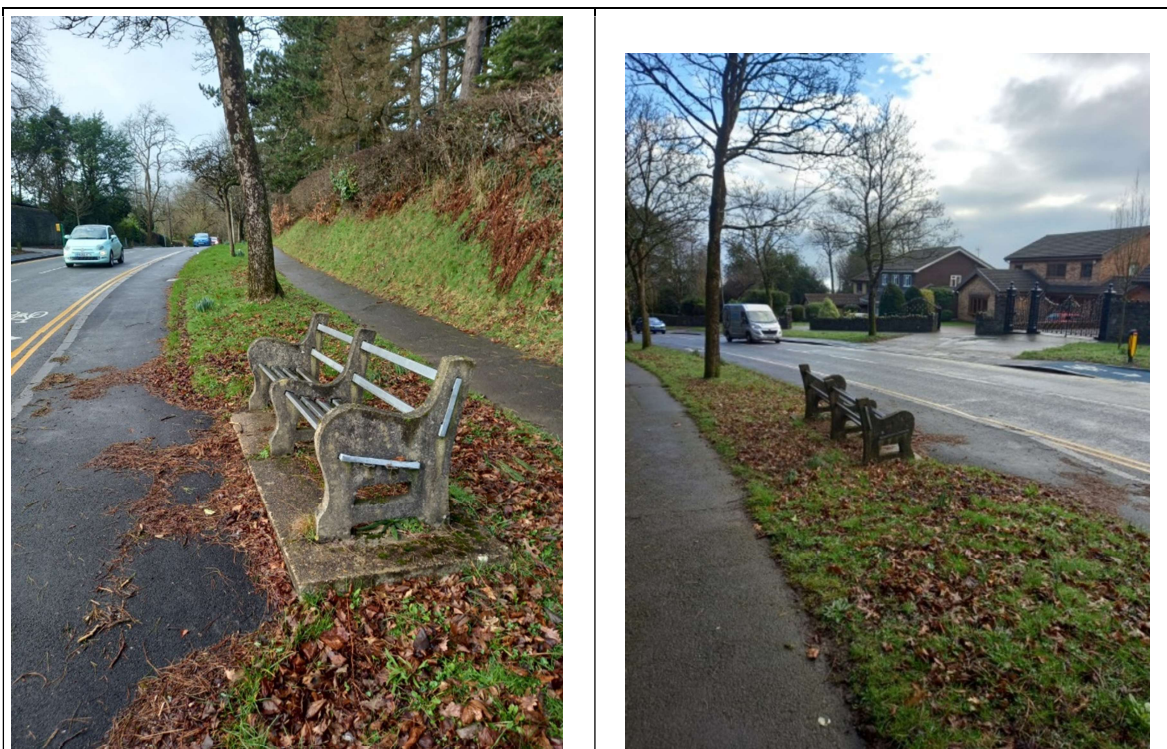
Cyclists Eastbound on Mayals Road downhill pass, possibly at speed, directly in front of an existing park bench. Pedestrians approaching or leaving the bench risk being struck with the potential of injury to both parties. There is no direct access to the bench from the existing footway, pedestrians have to cross the verge and occupy the cycle track to use

it. Vision and mobility impaired are disadvantaged and any benefit lost, even though it is located at the top of a hill where it would readily be utilised.

Park Bench- opposite Whitegates junction with Mayals Road.

It is recommended that the park bench be uplifted rotated and re-positioned with new hard standing so pedestrians can access it readily whilst avoiding conflict with passing cyclists.

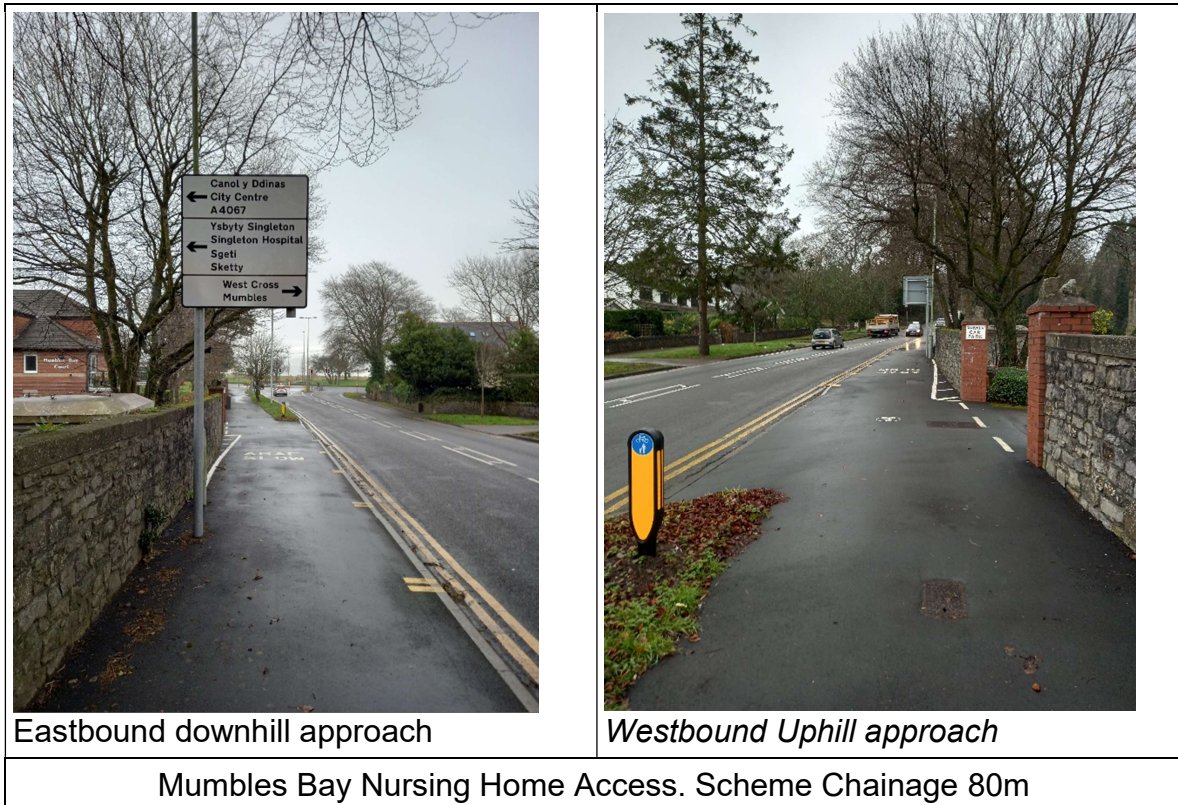
secondary collision with vehicles on the main carriageway with the potential for serious injury to the cyclist. Younger and less experienced riders may be particularly vulnerable, not anticipating obstruction to the path. This likelihood is increased on the downhill approach where higher speeds may be expected. Observations during the hours of darkness, further highlighted this concern.

Whilst measures in the form of a length of hatch markings and a “SLOW” have been provided inbound (East), on the downhill approach, these measures are insufficient and are not provided outbound (West), on the uphill approach.

It is recommended that, existing hatching provided be widened and a coloured infill applied to improve conspicuity, guiding cyclists further away from the access as they pass. This measure should also be repeated Westbound and TSRGD Diagram 1057, (cycle lane), applied within the access to improve driver awareness.

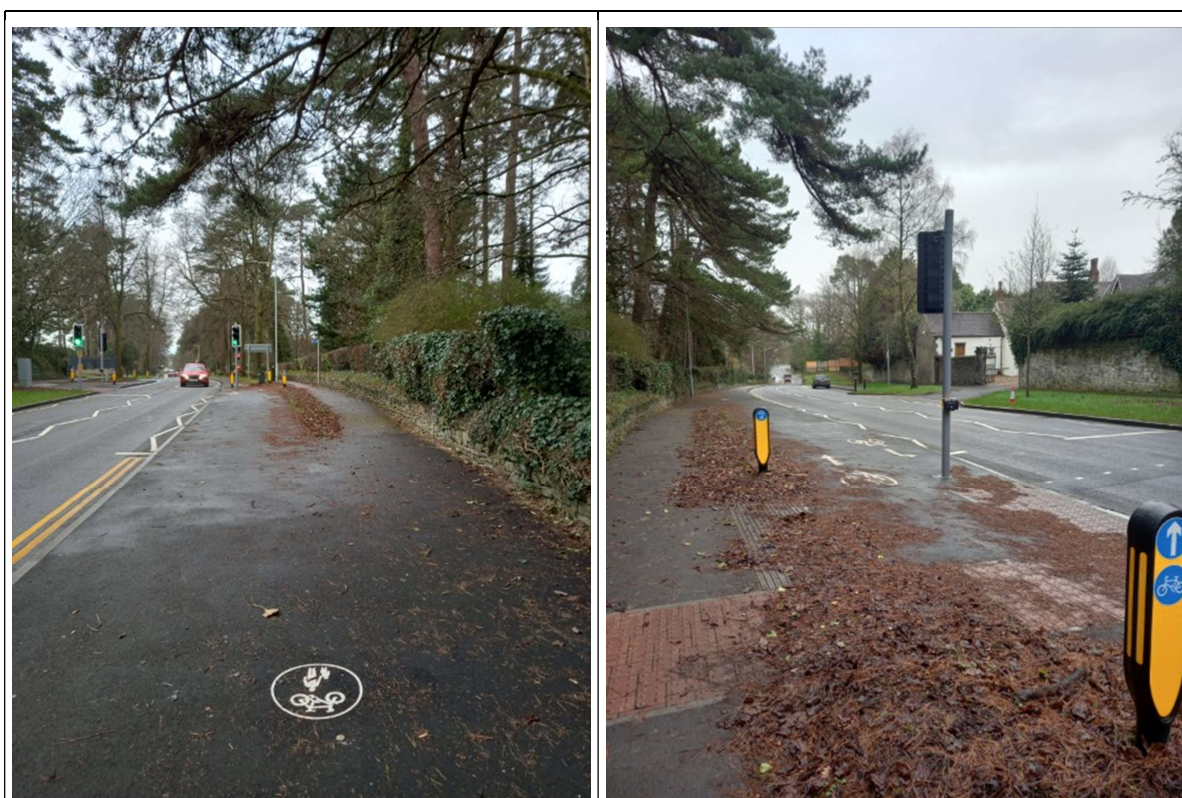
Summary: Unclear route signing, potential cyclist and pedestrian conflict.

Cyclist travelling outbound (West), uphill, on the shared use path (SUP), are expected to diverge at this point and utilise the controlled crossing to access the South side of Mayals Rd; sharing a short 30m section with inbound cyclists and pedestrians using the crossing, but avoiding others using the footway. This area lacks positive, easily read signing for cyclists and pedestrians and also presents an unclear route bisected by a non-surfaced and debris ridden triangle. This represents a maintenance liability as well as being a trip hazard to be avoided or negotiated by all but being especially difficult for vision impaired and people with mobility issues. Uncertainty, avoidance and sudden last minute changes to direction, could result in collision between cyclist and pedestrian, especially at increased speeds with the potential to result in injury.

Westbound transition from SUP to Cycle track at controlled crossing.

It is recommended that – this area be simplified, debris removed, sudden changes in surfaces remedied and clear, meaningful signing and markings provided to avoid uncertainty and last minute decision making. The provision should be simple, logical and consistent, in accordance with best practice.

Designers Response – *The design team acknowledge the issue and will introduce additional cycle direction markings indicating where cyclists are expected to ride. Hazard tactile paving will also be introduced where the existing pedestrian footway merges with the shared use facility. The effect of these measures will be reported in the Road Safety Audit Stage 4.*

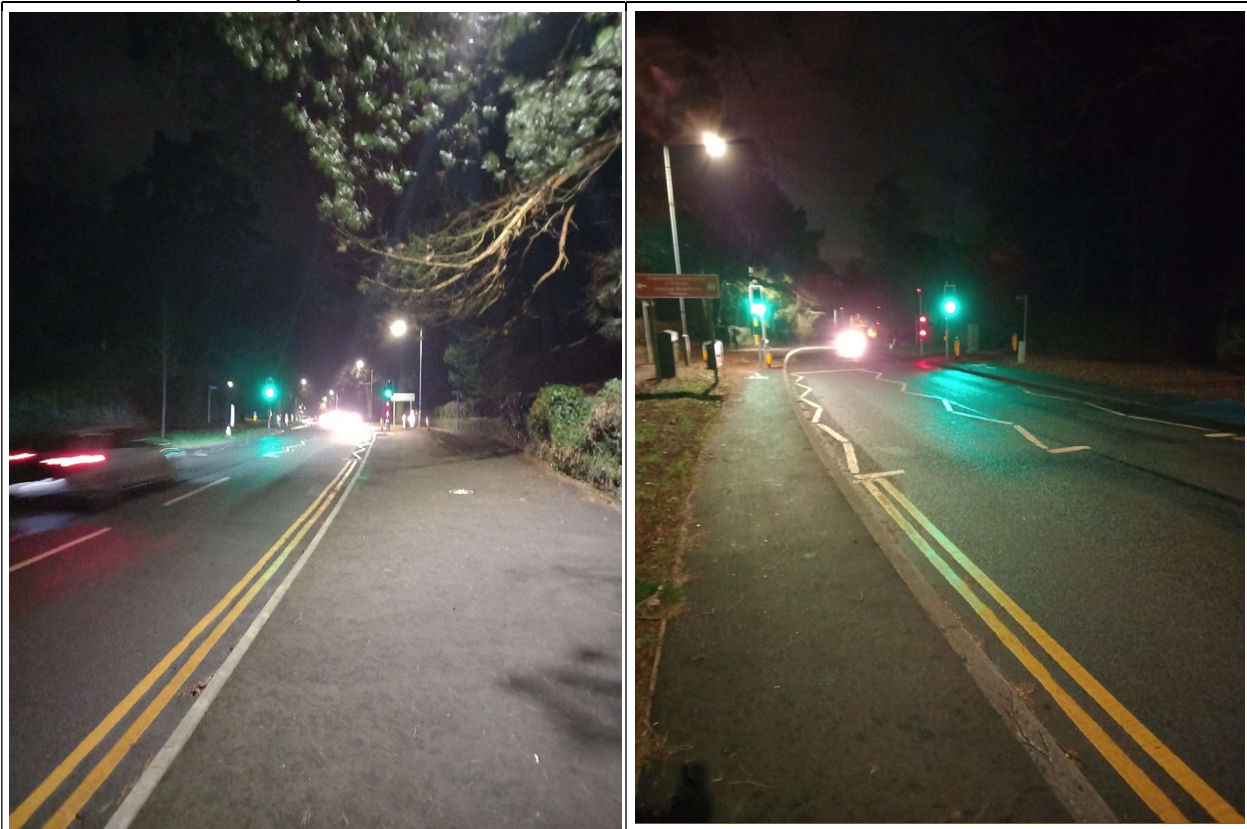
It was observed at night that pedestrians crossing from the south side to the north side of Mayals Road, using the controlled crossing, are not readily observed until they step well onto the crossing because that side of the street is not directly illuminated and the push button control is in darkness. This could result in pedestrians being struck by vehicles going ahead, especially if the push button isn't activated properly prior to crossing. This creates the potential for serious injury occurring.

Similarly, the signal control cabinet is in darkness and poorly orientated to open onto the footway during maintenance with the potential to block it almost completely. This in turn creates a hazard for pedestrians.

Controlled Pedestrian Crossing – Clyne Drive.

It is recommended that the area around this side of the crossing be properly illuminated. Also, that the orientation of the control cabinet be amended to provide a separate service area, not compromising the footway during Telematics maintenance.

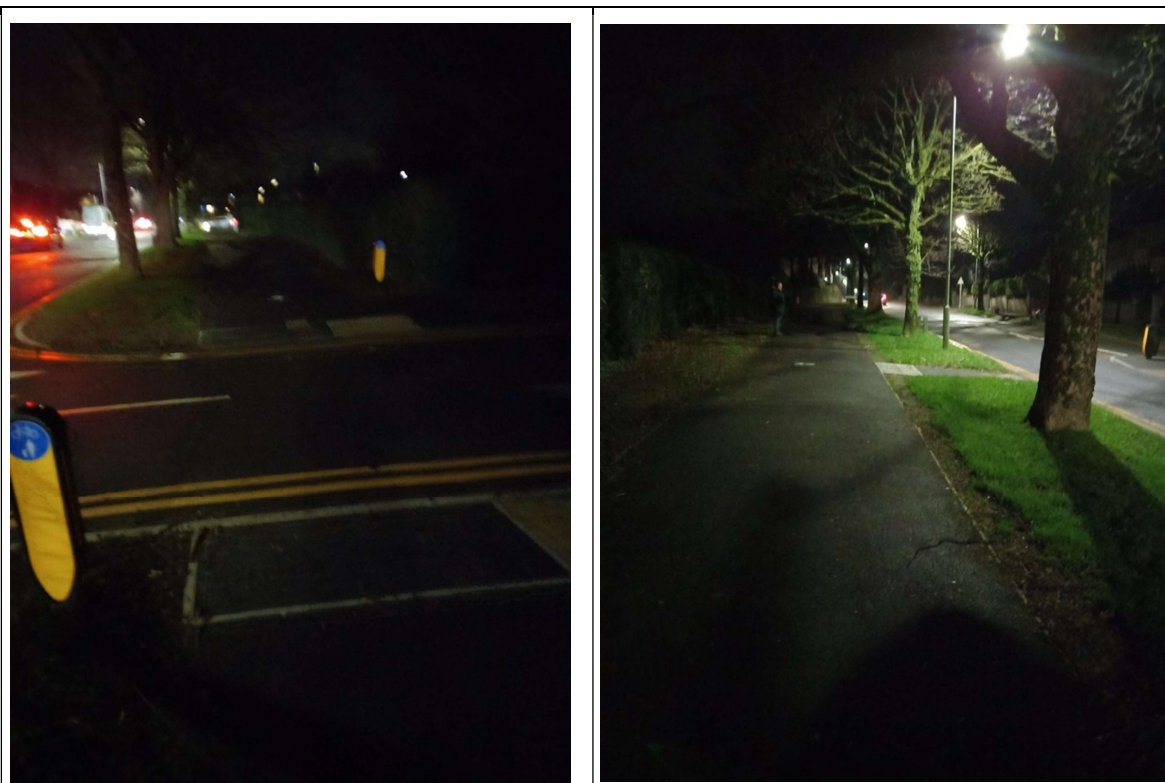
Whitestone Close, a small Cul-De-sac which accesses Mayals Road beyond Fairwood Road, is poorly lit being in shadow between trees and the existing street lighting. Night-time observations revealed that pedestrians and cyclist using the shared use path would only become aware of the access at the last minute, because of poor light levels. This could lead to sudden braking and loss of control with the potential for serious injury to cyclists colliding with emerging vehicles. Similarly, traffic, turning in from Mayals Road at night would only see cyclists or pedestrians at the last minute.

It was also noted that the existing bollards retro-reflectivity is poor.

Whitestone Close (Audit Team Member on SUP)

It is recommended that additional street lighting be provided at this junction and extra retro-reflective bollards be provided to highlight the change in surface.

Designers response - *As noted in Problem 2, discussions with Swansea Council's Public Lighting Section during the design phase confirmed the existing public lighting system along Mayals Road conforms to the standards required in BS:EN13201. However, it is noted that the existing tree canopy may reduce the efficacy. The design team will co-ordinate with the Tree Services Team to ensure tree branches are pruned and crown lifted so they do not interfere with the street illumination levels.*

As also noted in Problem 2, the design team are satisfied that the reflectivity of the bollards is consistent with the required specification.

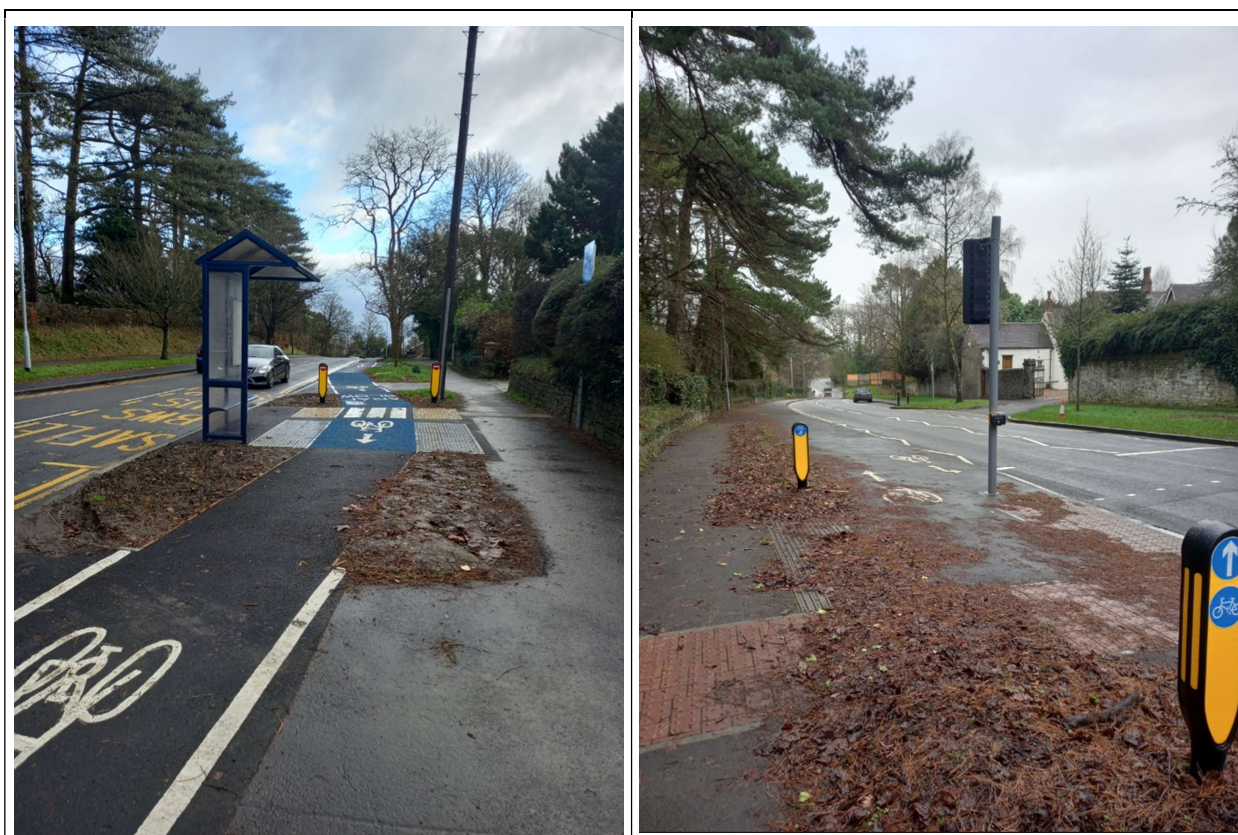
Throughout the scheme multiple changes in surface and minor random areas of non-paved ground between, or adjacent to scheme provision and street furniture, have quickly become slippery, muddy or littered with material, tree branches, composting leaves and

organic material. This presents a major problem for all NMU user of Mayals road especially cyclists, mobility impaired and vision impaired. Facilities intended as improvements, could easily become a hazard if not managed.

Scheme wide

It is recommended that all compromised areas of the scheme be clear and unnecessary changes in surface material and areas with maintenance issues be removed and infilled to present a more uniform, user friendly facility. In addition, that areas that require attention annually be identified, in order to establish a maintenance program.

Designers Response – As noted in problem 1 above, Swansea Council Highways Department operate a programmed and a Reactive Highway Maintenance Regime. Mayals Road is a primary distributor that benefits from the regularly programmed mechanical sweeping of its highway infrastructure. Swansea Council's Highways Maintenance Department has a team of Highway Inspectors who identify issues such as this.
